FLIGHT DECK REFUELLING HOSE FAILURE HMCS PRESERVER

Technical Memorandum

DREA TM 2000-022

January 2000

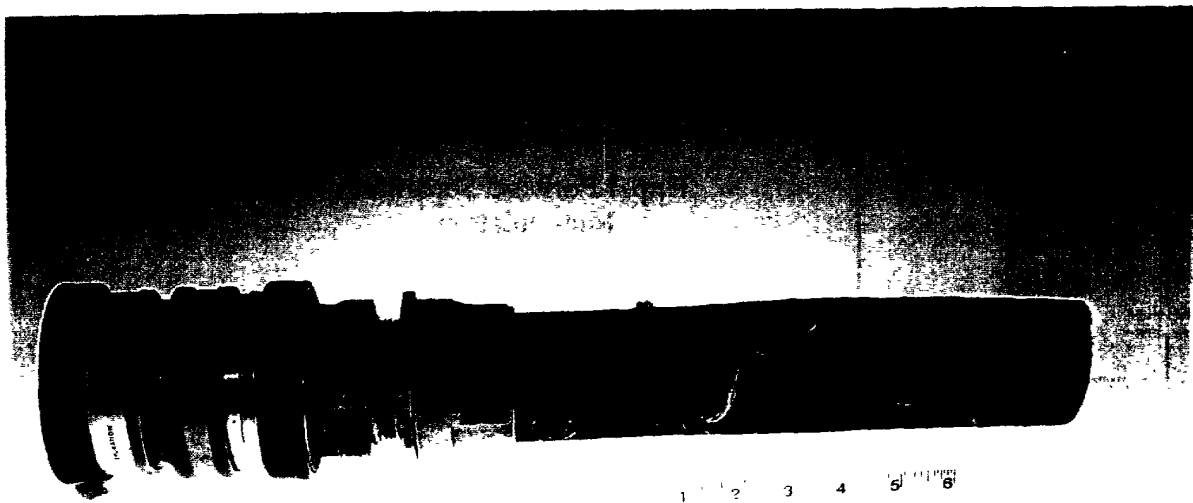
The failed section of hose is shown in Figure 2. The failure penetrated the hose, that is both the inner tube and cover were split over a distance of approximately 6 inches and the reinforcing fibres were broken. One end of the failure surface approached to within approximately 2 inches of the coupling. Figure 3 shows an expanded view of the failure surface on the exterior of the hose.

Figure 2 – Photograph of the failure in the refuelling hose from HMCS Preserver. Note the proximity of the failure to hose coupling.

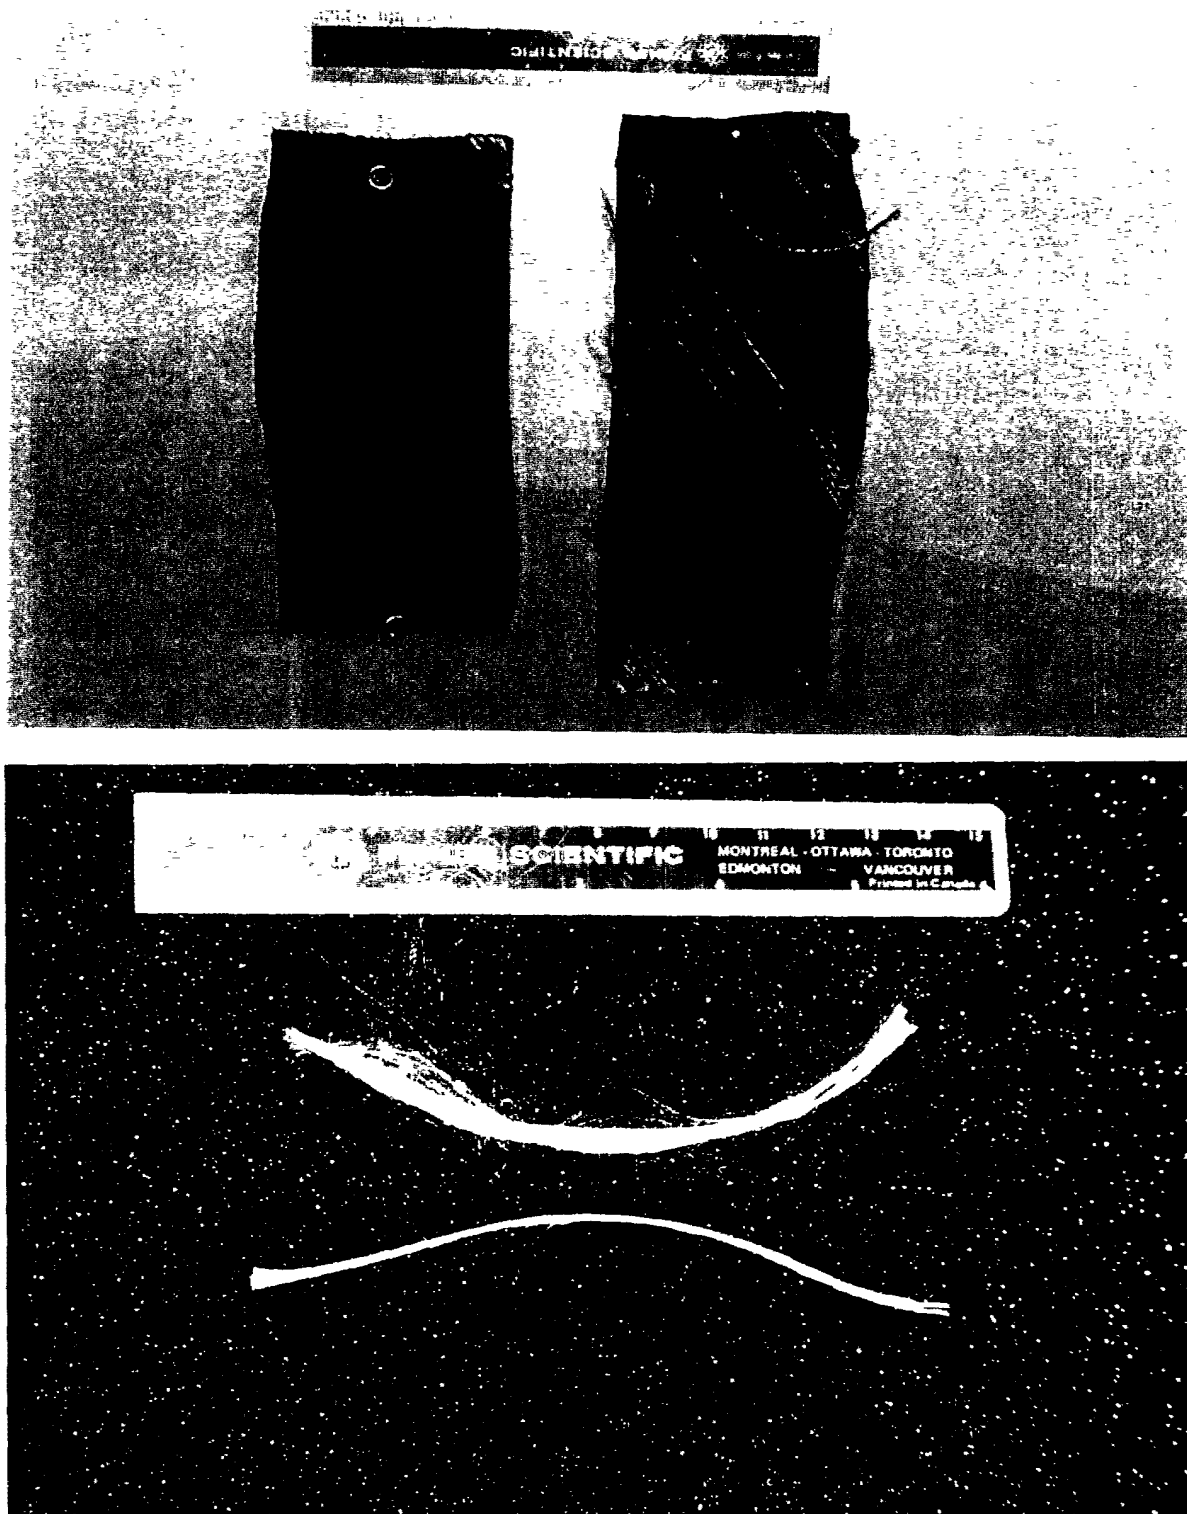
The reinforcing fibres could be pulled away from the inner tube or outer cover easily. The inner tube and outer cover after removal of the reinforcing plies are shown in Figure 4a. It can be seen that the plies came away from the inner tube more cleanly than from the outer cover. There was also a significant difference in the appearance of the inner and outer plies of reinforcing fibres when they were separated from the inner tube and outer cover of the hose respectively. The inner plies were string-like while the outer plies were looser and did not appear to be twisted as much as the inner plies. Examples of the inner and outer reinforcing plies are shown in Figure 4b.

The inner and outer fibres are shown in Figure 4. It can be seen that the outer fibres sustained some damage in separating them from the hose. To determine if this was responsible for the difference in the load/stroke response of the inner and outer fibres, the inner fibres were manipulated in an attempt to reproduce the damage to the outer fibres. Two things were tried, untwisting or unraveling the fibres and removing some of the fibre to reduce its weight.

Figure 4 – a) Refuelling hose inner tube (left) and outer cover (right) after removal of reinforcing fibre plies. b) Reinforcing plies from outer cover (top) and inner tube (bottom)

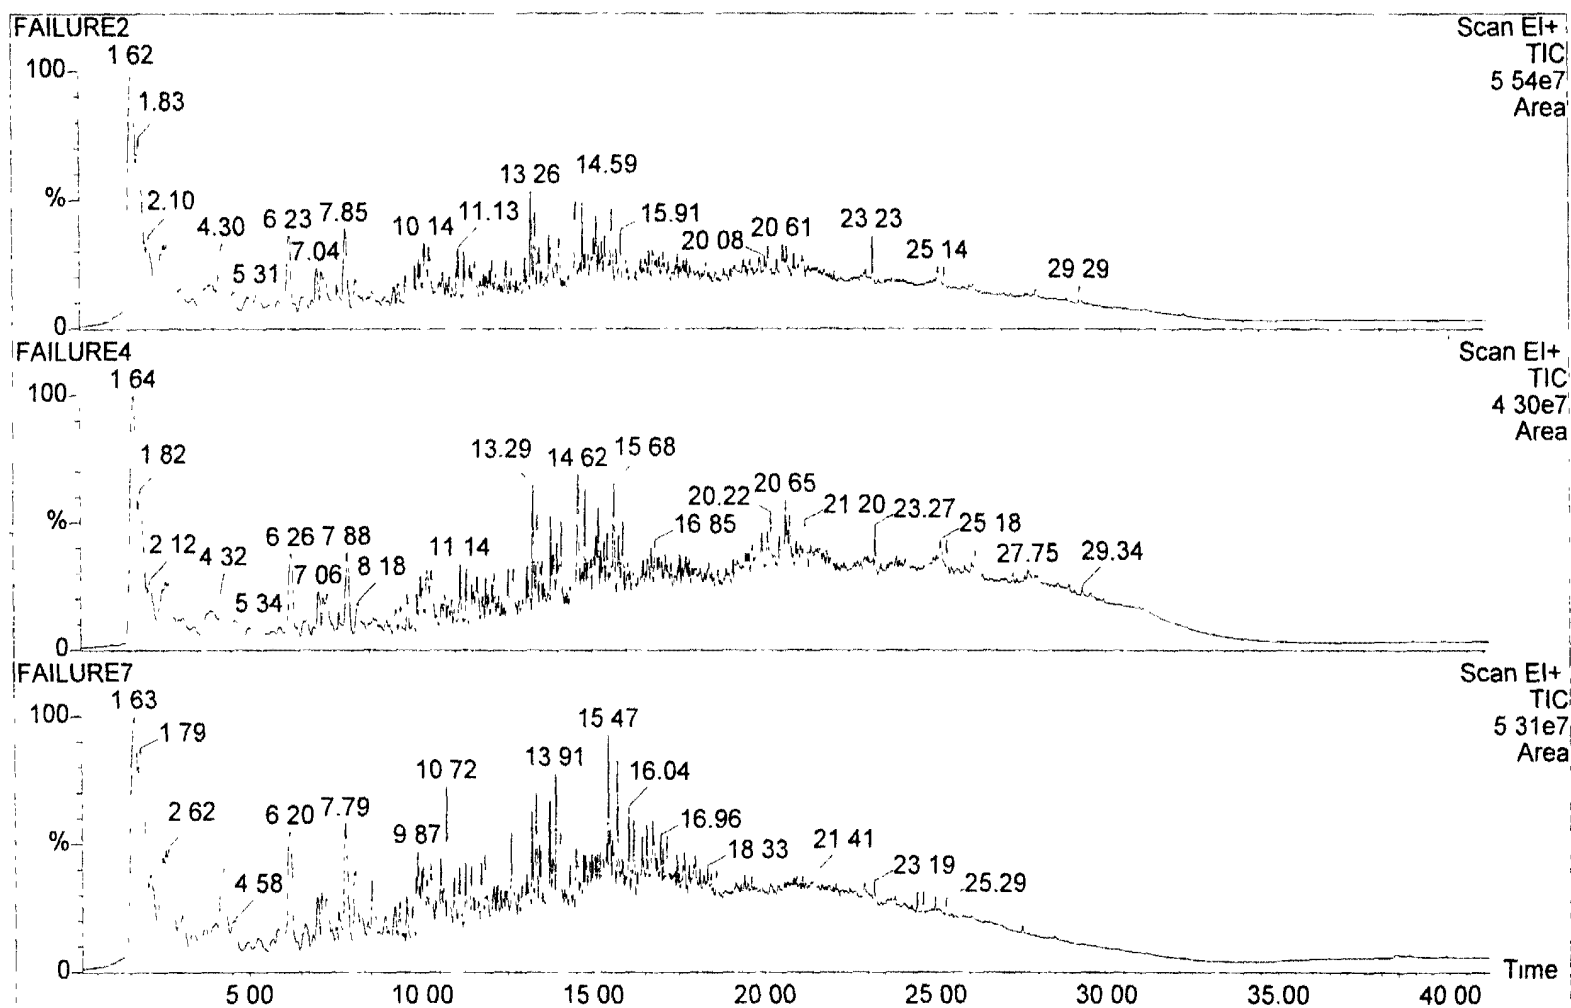
Pyrograms of the outer rubber cover, the exterior of the outer rubber cover, and the inner rubber tube are shown in Figure 5. Comparison of the pyrograms indicates that the rubbers giving rise to these chromatograms are similar. Mass spectral analysis of the peaks indicates that the pyrolysis products include the dimer of butadiene, ethenylcyclohexene, at 6.23 minutes in Figure 5a, and several peaks characteristic of the pyrolytic degradation of poly(butadiene-acrylonitrile) rubber at 8.60 minutes, 10.10 minutes, 10.79 minutes, and 15.43 minutes. These compounds have molecular weights of 93, 103, 107 and 160 respectively.

The pyrograms of the outer rubber cover (Figures 5a and 5b) also contained 1-chloro-4-(1-chloroethenyl)cyclohexene (~14.80 minutes). 1-chloro-4-(1-chloroethenyl)cyclohexene is the dimer of the monomeric unit of poly(chloroprene) rubber and is the major pyrolytic degradation product of poly(chloroprene) rubber. No evidence of poly(chloroprene) rubber was found in the sample from the inner tube.

Figure 5 – Pyrograms of a) outer rubber cover, b) the exterior of the outer rubber cover, and c) the inner rubber tube of the failed Titan MIL-H-6615E refueling hose.

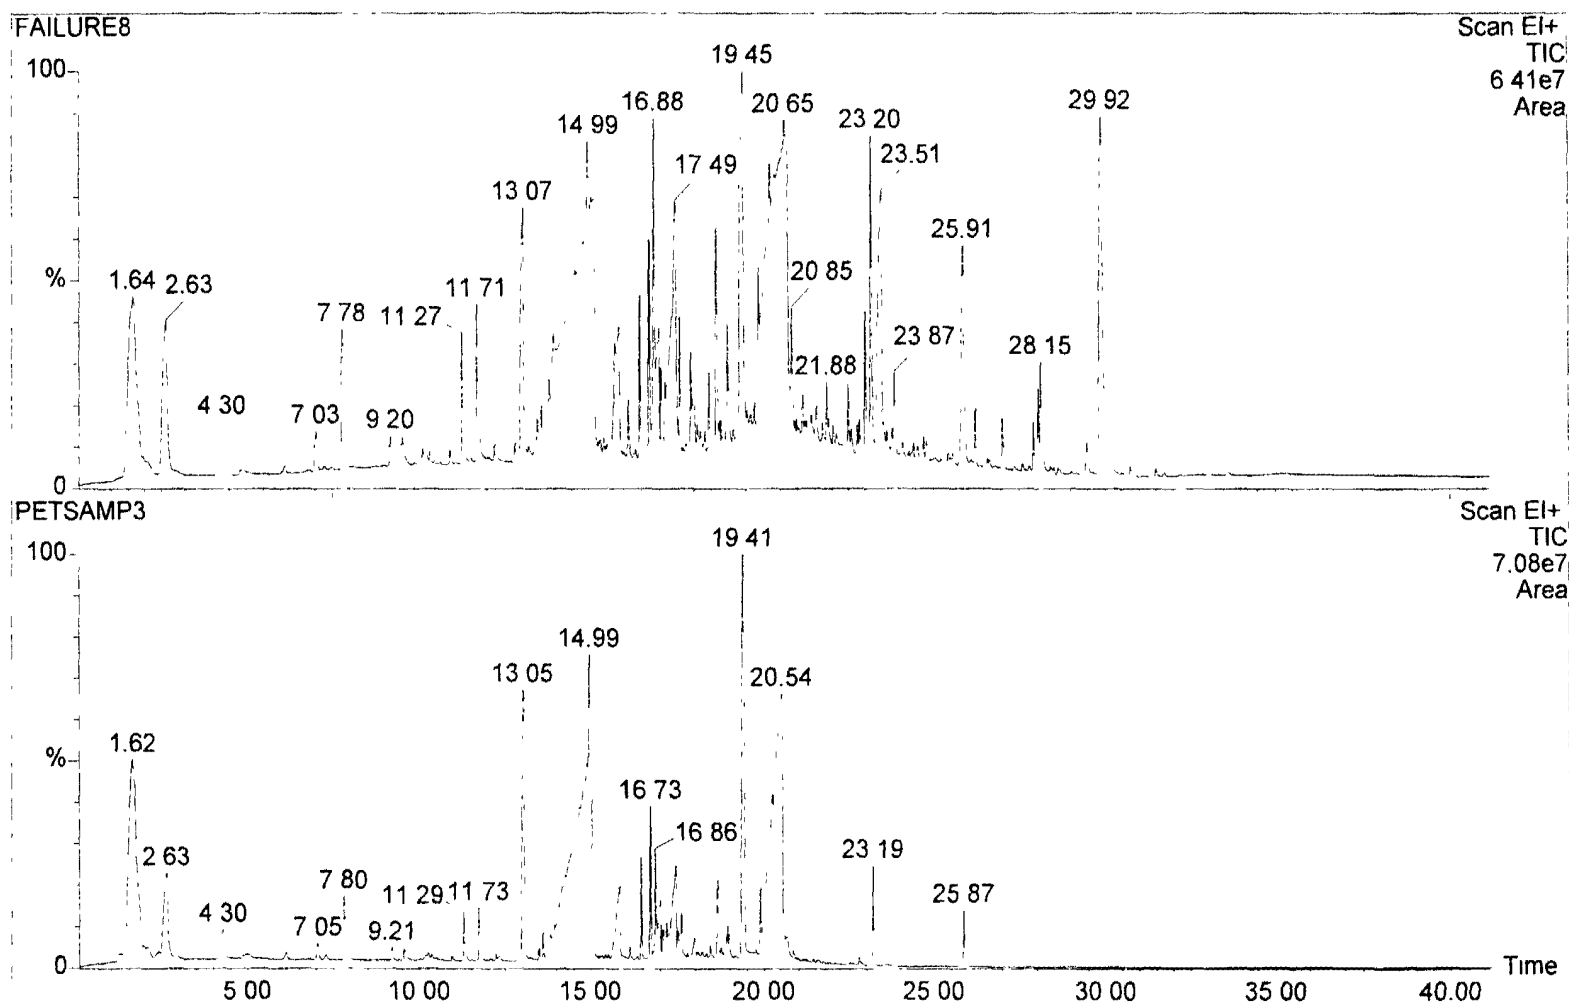
The pyrogram of the reinforcing material is shown in Figure 6a. Analysis of the pyrolysis degradation products indicated that the fibres were composed of poly(ethylene terephthalate) or PET. A pyrogram of a standard sample of PET is shown in Figure 6b.

Figure 6 - Pyrograms of a) reinforcing fibre from failed Titan MIL-H-6615E refueling hose and b) standard sample of poly(ethylene terephthalate).

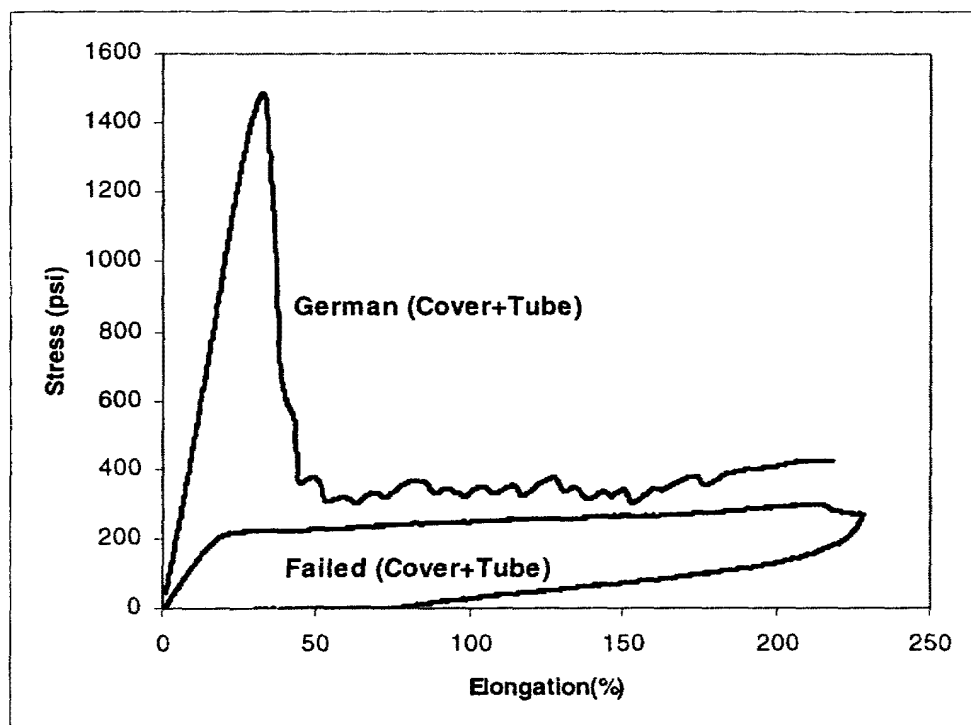
The plots of stress versus elongation for the intact tensile specimens from the Titan and German refueling hoses are shown in Figure 14. It is apparent from the plots that the Titan and German hoses are different. The Titan fuel hose did not break during the test and both loading and unloading curves are found in the figure. The maximum stress at 230% elongation was approximately 300 psi. As the Titan tensile specimen did not rupture during the test, 230% elongation is not the limit for the Titan tensile test specimens. The maximum elongation (230%) of the specimens was limited by the stroke of the Instron Model 8801 testing machine (6 inch maximum) and the initial sample gauge length of 2.3 inches.

In contrast to this the German hose began to fail at 40% elongation and supported a maximum stress of 1500 psi at that elongation. The failure of the German hose could be followed during the tensile test. The failure initiated with the rupture of the reinforcing fibres when the stress reached 1500 psi. As the fibers ruptured and separated, the load supported by the specimen dropped rapidly. The outer cover could not sustain the load and began to rip slowly. The load supported by the specimen continued to drop and was transferred to the inner tube. Initially the inner tube was loaded over a short portion

Figure 14. Plots of stress versus elongation of the intact tensile specimens from the Titan and German refueling hoses.

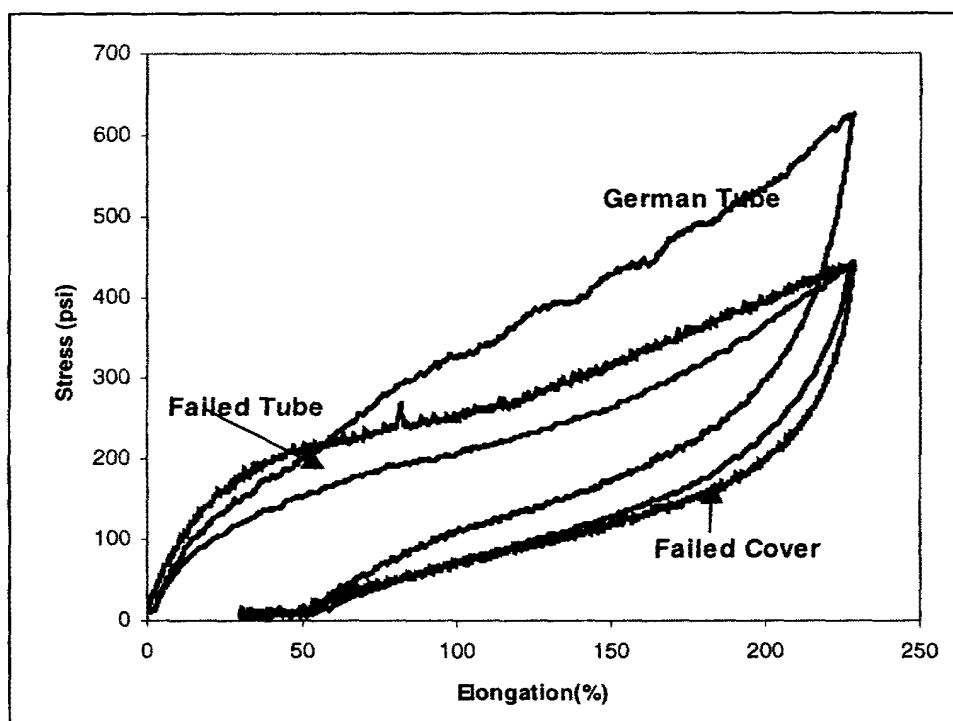
Plots of stress versus elongation for tensile specimens taken from the outer cover and inner tube of the Titan hose, and the inner tube of the German hose are shown in Figure 15. The slopes of the stress versus strain plots indicate that the inner tube from the German hose has a slightly larger modulus of elasticity than the inner tube of the failed hose. The German inner tube reached a stress of 630 psi at 230% elongation while the inner tube and outer cover of the failed hose reached stresses of 440 psi at 230% elongation.

Figure 15. Plots of stress versus elongation for tensile specimens from the outer cover and inner tube of the Titan hose, and the inner tube of the German hose.

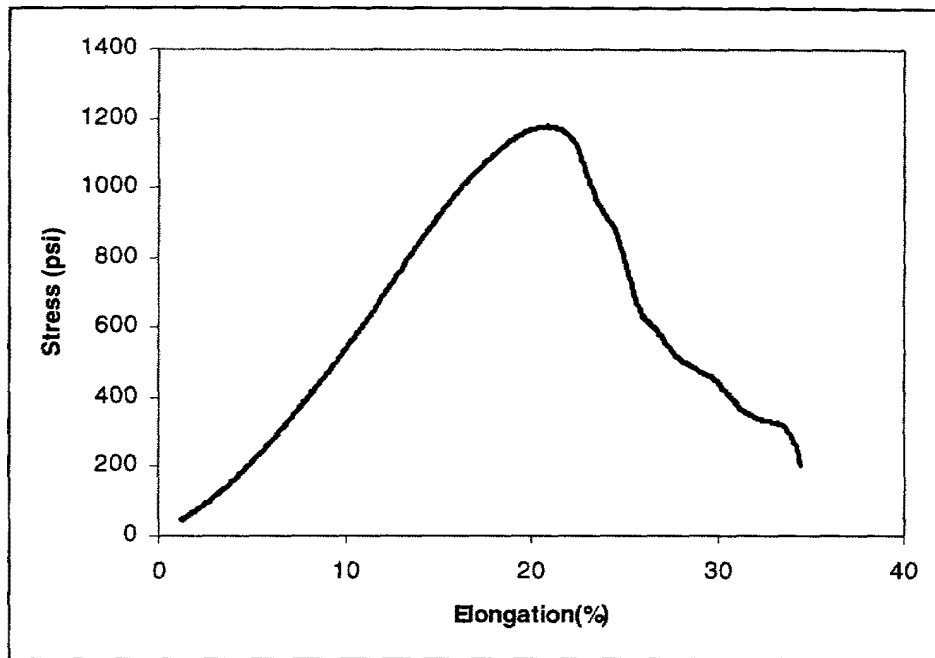
The tensile test result for the outer cover of the German hose is shown in Figure 16. This was plotted separately because it was not possible to separate the outer layer of reinforcing fibres from the outer cover. It can be seen in Figure 16 that the reinforcing fibres had a significant effect on the performance of the sample, i.e., the maximum stress increased to 1200 psi and the sample failed at 34% elongation.

Figure 16. Plot of stress versus elongation for tensile specimen from the outer cover of the German hose. This sample had the outer layer of reinforcing material attached.

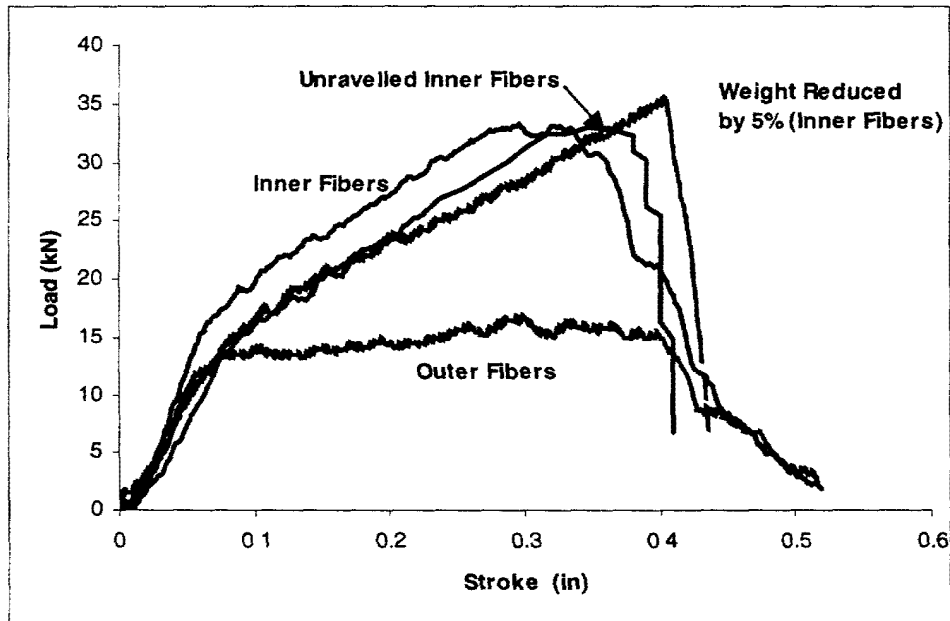
As neither unraveling nor reducing the weight of the inner fibre by 5% resulted in a load/stroke response similar to the outer fibre from the failed hose, this suggests one of three things. These are; the inner and outer fibres were different, the outer fibres were altered during manufacture of the hose, or the outer fibres were damaged during removal from the hose.

Figure 17. Plots of load versus stroke for fibres from the inner and outer layers of reinforcement from the Titan hose, an unraveled fibre from the inner layer, and a weight reduced inner layer fibre.

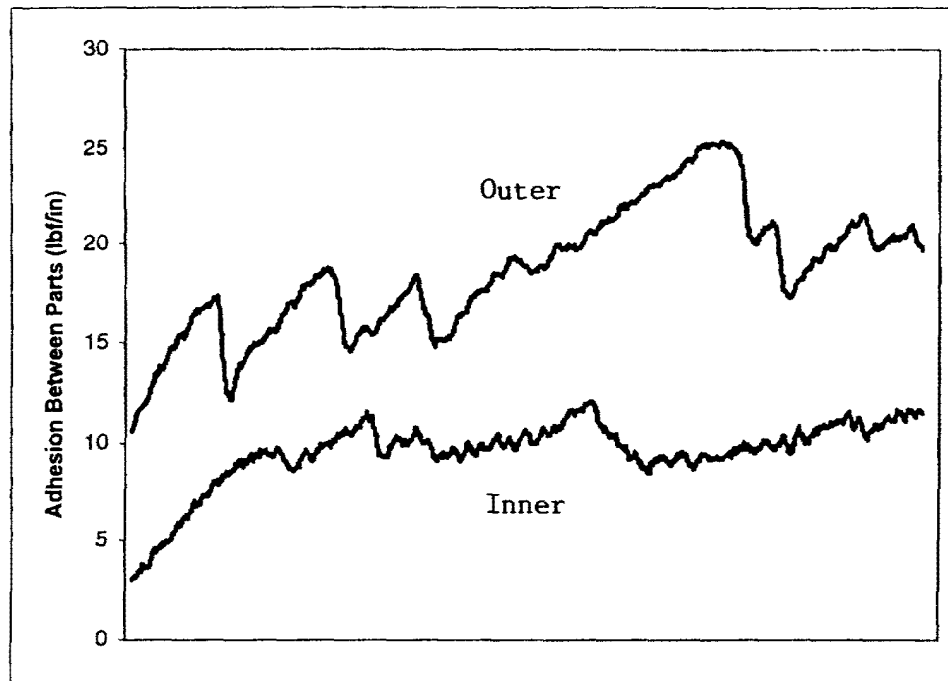
The reinforcing fibres were not uniformly wound around the hose and the adhesion of the inner layer of reinforcing fibres to the rubber portion of the hose was significantly less than the adhesion of outer layer of reinforcing fibres to the rubber portion of the hose. Testing indicates that the adhesion for the inner layer of reinforcing was less than specified in MIL-H-6615E. The mechanical responses of the inner and outer layers of reinforcing fibres were also different. These factors may have been responsible for the failure of the hose.

Figure 18 - Plots of the load per lineal inch to separate the inner and outer reinforcing fibres from the remainder of the Titan hose.
